## Case Study

### Installation of AEGIS SGR™ Bearing Protection Ring at Time Life Building

**Date:** March 9, 2009

**Location:** Time Life Building  
1271 6<sup>th</sup> Avenue  
Rockefeller Center  
New York City, NY

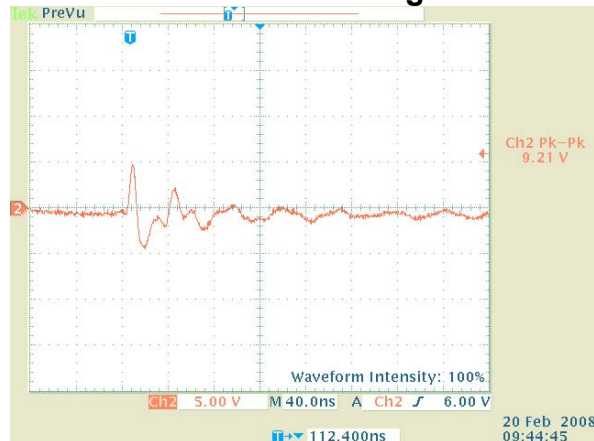
**Ground Reference Reading**

**Observation:**

Volts: 9.21 V pk-pk  
Oscilloscope setting: 40.0ns/div  
Date: 20-Feb-08  
Time: 9.44 am

Ground reference reading was taken with oscilloscope touching the motor frame.

Voltage measured is ground noise produced by radiated stray voltages

Ground reference voltage may be subtracted from the grounded shaft voltage measured after AEGIS was installed.

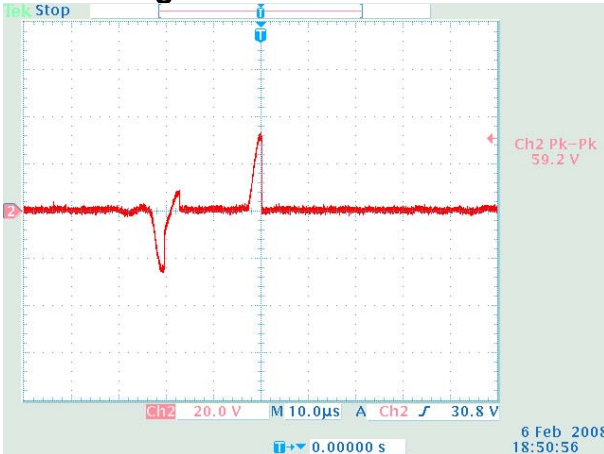
<p><b>Reading #1</b></p> <p style="text-align: center;"><b>Voltage 59.2</b></p> <p><b>No Bearing Protection</b></p>

<p><b>Observation:</b> Volts: 59.2 V pk-pk Oscilloscope setting: 10.0μsec/div Date: 6-Feb-08 Time: 18:50 pm</p>	<p><b>Reading #1</b></p> <p style="text-align: center;"><b>Voltage 8.86</b></p> <p><b>AEGIS SGR Bearing Protection</b></p>

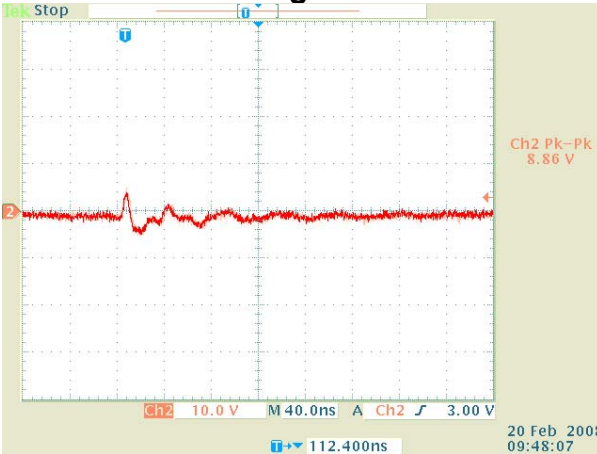
<p><b>Observation:</b> Volts: 8.86 V pk-pk Oscilloscope setting: 40.0ns/div Date: 20-Feb-08 Time: 9.48 am <b>Same as ground reference reading</b></p>
<p><b>Reading #2</b></p> <p style="text-align: center;"><b>Voltage 37.2</b></p> <p><b>No Bearing Protection</b></p>

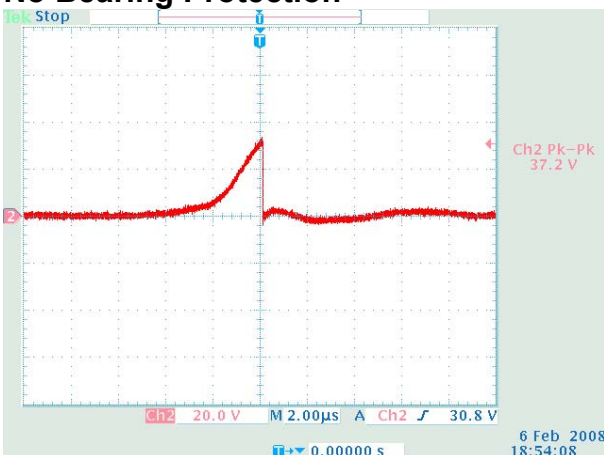
<p><b>Observation:</b> Volts: 37.2 V pk-pk Oscilloscope setting: 2.00μsec/div Date: 6-Feb-08 Time: 18:54 pm</p>	<p><b>Reading #2</b></p> <p style="text-align: center;"><b>Voltage 11.2</b></p> <p><b>AEGIS SGR Bearing Protection</b></p>

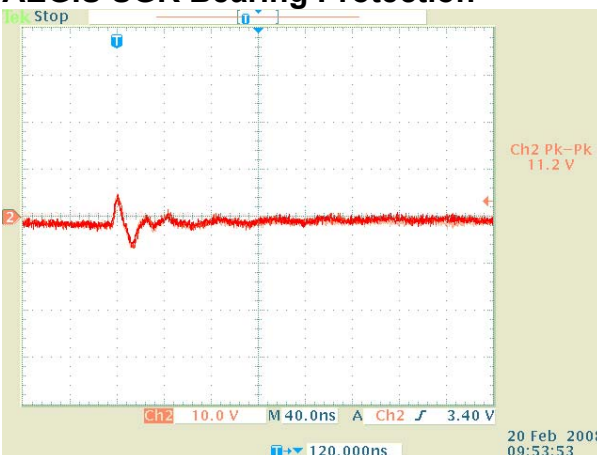
<p><b>Observation:</b> Volts: 11.2 V pk-pk Oscilloscope setting: 40.0ns/div Date: 20-Feb-08 Time: 9:53 am <b>Same as ground reference reading</b></p>

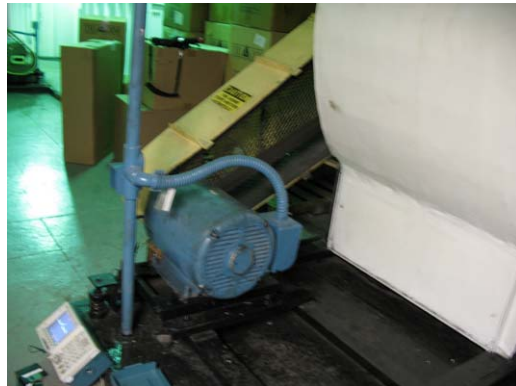
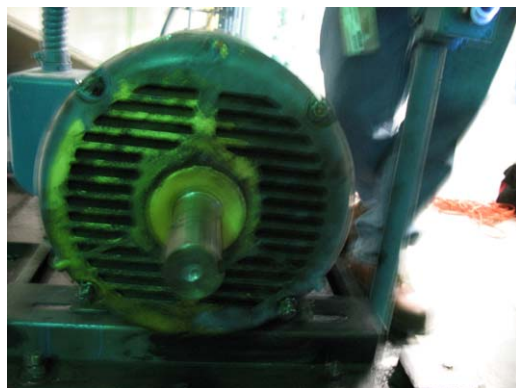
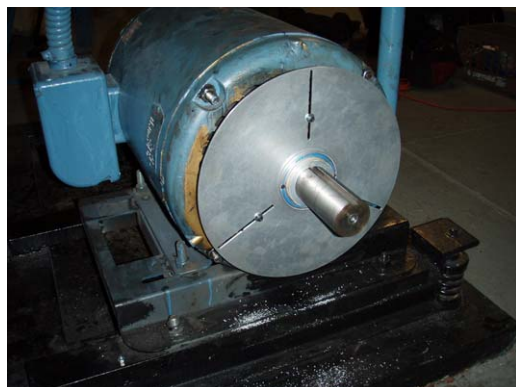
**Field Installation:**

Note: Mounting plate OD dimensions were established before attached equipment was removed. Once the attached equipment was removed, a more qualified measurement was taken. The plate could have been only 7" in diameter.

**AEGIS SGR PN:** SGR-71.5-3FH  
**ETE Collar PN:** ETE75-2.125-K-1  
**Mounting Kit:** SGR-M330-1 (custom 13" diameter plate with spacers)

1. Attached equipment was disassembled for AEGIS SGR installation.
2. Shaft was cleaned and free of any coatings, paint, or other nonconductive material. Shaft was lightly sanded to remove any oxide coating.
3. DE shaft has a shaft step. Step was not long enough to mount SGR direct to step diameter. A mounting kit was needed for installation.
4. Installed ETE Collar onto the shaft and secured with set screw.
5. AEGIS SGR and attached mounting plate was placed onto the ETE Collar. SGR was evenly spaced around the ETE Collar. Drill points were marked on the end bell of the motor. SGR and mounting plate was removed.
6. Drilled 3 holes using a #29 drill. Depth of 1/4". Tapped each hole with a #8-32 tap.
7. AEGIS SGR and attached mounting plate was installed and secured to the motor with spacers and screws.

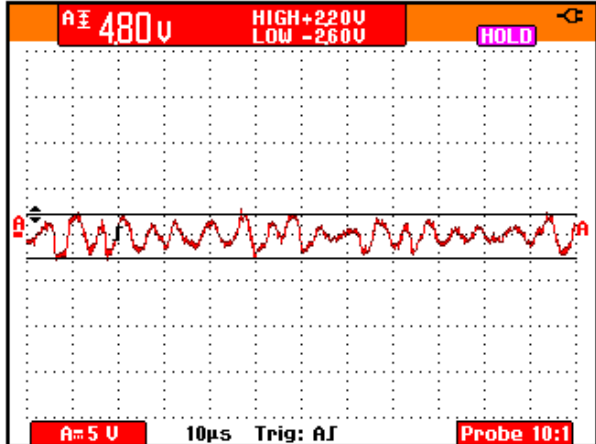
<p><b>Reading #1</b></p> <div style="background-color: blue; color: white; padding: 5px; text-align: center; width: fit-content; margin: 0 auto;">Voltage 4.80</div> <p><b>AEGIS SGR Bearing Protection</b></p>

<p><b>Observation:</b></p> <p>Volts: 4.80 V pk-pk Oscilloscope setting: 10.0us/div Date: 09-Mar-09</p>

- (7) The reading observed after 12 months was also a greatly reduced peak-peak reading of 4.8 volts indicating continued effective operation of the AEGIS SGR.

Note that the voltage reading after 12 months was actually less than the initial voltage reading on 20-Feb-2008. Normal shaft voltage discharges with conductive micro fiber shaft grounding ring installed on a VFD driven motor will vary based on the operation of the motor at the time that measurements are taken.

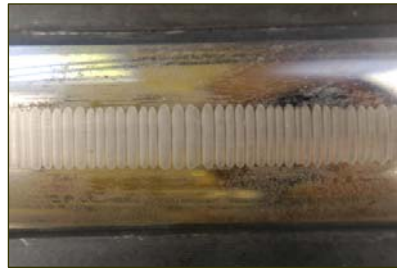
Fluting on bearing race results from continuous electrical discharges

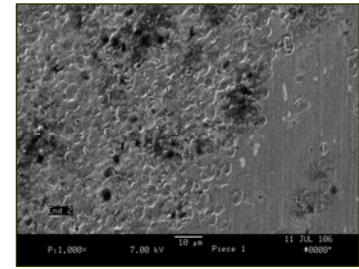
Scanning Electron Microscope of pitted/fluted surface

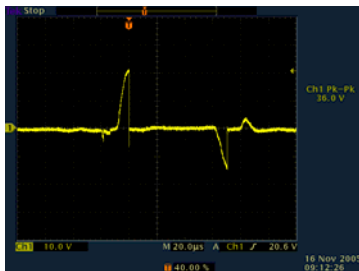
Typical Shaft Voltage Reading of VFD induced EDM effect

- Shaft voltages will vary depending on motor and system. Typical peak to peak voltages are 20 to over 60 volts and may be measured on the motor shaft while rotating.
- Shaft voltages will rise until they overcome the bearing lubricant and will then rapidly discharge through the motor bearing which is seen in the rapid collapse from the peak to ground.
