Remember to follow the ABCs of bearing inspection

By Chuck Yung
EASA Senior Technical Support Specialist

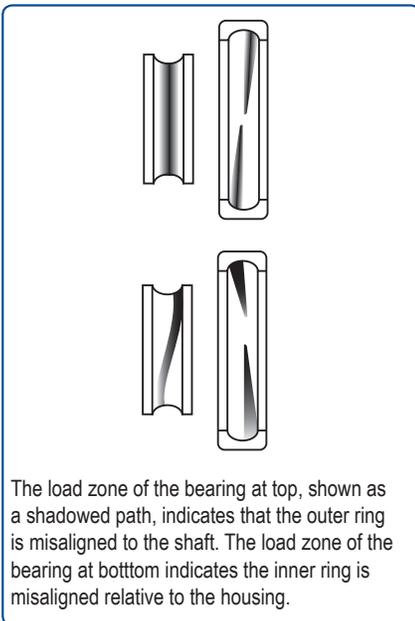
Figure 1. Diagonal wear paths indicate misalignment.

- Misalignment.** A diagonal wear path, as shown in **Figure 1**, indicates misalignment.
- Preloading.** If the wear path is offset in opposite directions on inner versus outer race, the bearing was preloaded during service (**Figure 2**).

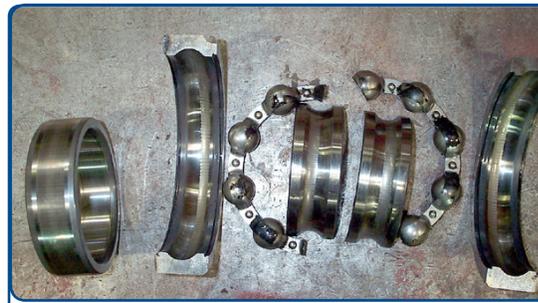
Figure 2. Wear paths offset in opposite directions on inner versus outer race indicates the bearing was preloaded during service.

Are both ends preloaded outward? That means the motor does not have sufficient room for thermal expansion of the shaft. Corrective machining is required to prevent a repeat failure.

If only the drive end bearing was preloaded, that means the preload was the result of external forces, specifically during the alignment and coupling phase. Let your customer know, as soon as possible, that the alignment procedures

need to be reviewed. The motor might be bolt-bound, in which case there are two viable options. The first is to shift the driven equipment during the alignment process. The other option, which is often more practical, is to drill the base bolt holes one nominal size larger to gain the necessary room for a proper alignment.

Whatever you find and however you solve the problem—don't just change the bearings. An internal preload condition requires the non-locating bearing housing to be machined deeper to gain sufficient room for thermal expansion of the shaft. A good rule of thumb is to provide 0.010" per foot (0.75 mm per meter) of shaft length between bearings.

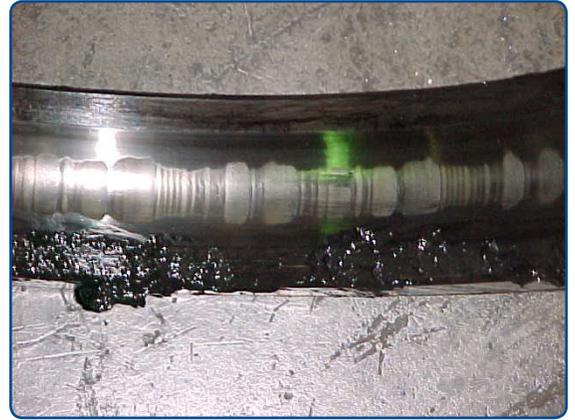
- **Shaft currents and contamination.** A washboard appearance called fluting (**Figure 3**) is indicative of shaft currents (also known as bearing currents), which are increasingly common when motors are powered by variable-frequency drives (VFDs). A highly frosted wear path is either caused by VFD-related shaft currents or dirt embedded in the grease. Use a 20x magnifier to look more closely. Electrical pitting on the race or rolling element will have a melted appearance along the edges, whereas contamination causes a rougher cratering.

Figure 3. Bearing fluting due to shaft currents.

Shaft/bearing currents call for insulation of the non-drive end if the motor is operating from sinusoidal power (or for DC machines). A motor operating from a VFD, however, requires more steps to solve the fluting issue. Both ends should be insulated, and a shaft grounding brush should be installed. There are several good options for each. First, insulating the bearings can be accomplished by insulating the bearing housing (good), by insulating the shaft journal (better),

or by installing hybrid bearings (best). The shaft grounding brush can be provided by several suppliers, but the brush must be a low-resistance brush. That means a high-silver-content brush, not a carbon brush as used in DC machines. ●
