Aegis protects motors from shaft voltages

Variable-frequency drives – commonly used for energy-efficient control of AC motors – can induce shaft voltages which lead to bearing and motor failure. Shaft grounding rings have been proven to protect such motors from damage, says MARTIN DEISS of Electro Static Technology.

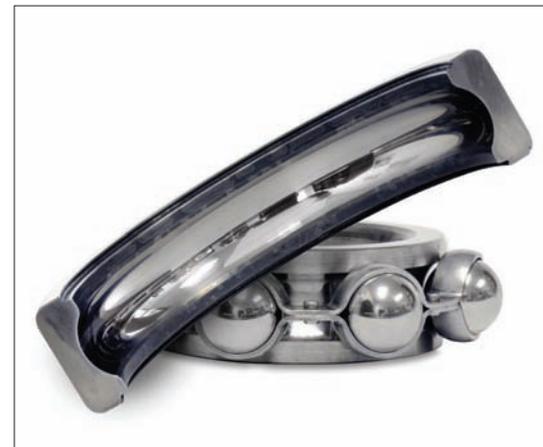
Figure 2: Mirror-smooth surfaces of brand new bearing races minimise friction.

Bearings, which normally have a mirror-smooth bearing surface [Figure 2], can be damaged by electrical discharges. Without protection, shaft voltages pass through the bearings and cause undesirable electrical discharges. Spark erosion damages the bearing surfaces and leads to

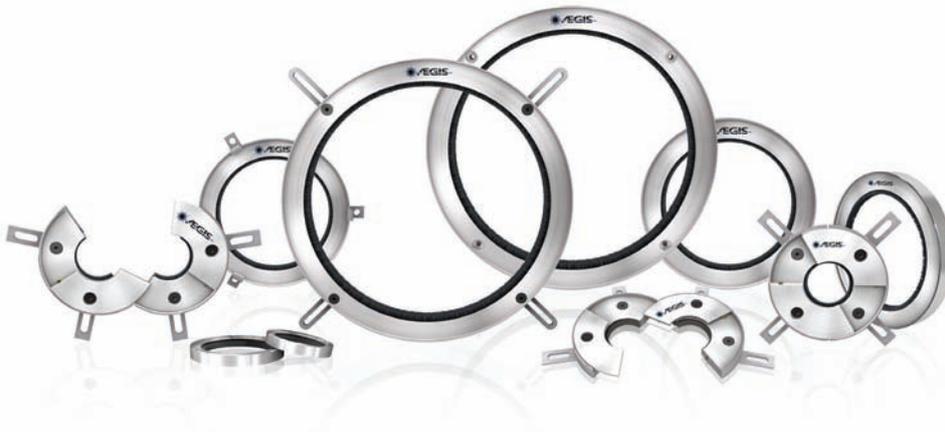
Figure 1: Aegis shaft grounding rings.

In most cases, a reliable and cost-effective way to minimise electrical bearing damage and increase the reliability of VFD-controlled motors and systems is the use of an Aegis shaft grounding ring (combined with an insulated bearing for motors larger than 75-100 kW) [Figure 1]. The Aegis branded products are marketed by Electro Static Technology- ITW, a global manufacturer and designer of static control devices for equipment manufacturers and users.

shaft grounding rings offer far greater efficiency especially in avoiding high-frequency bearing currents. The bearing protection rings consist of highly conductive microfibres, which are secured in the patented FiberLock channel. Scalable to any shaft diameter, the fibres surround the motor's shaft, offering a low-impedance path from the shaft to frame and then to ground thus reliably diverting damaging currents. Since the microfibres work with little or no contact with the shaft, they are not subject to wear like conventional carbon brushes.

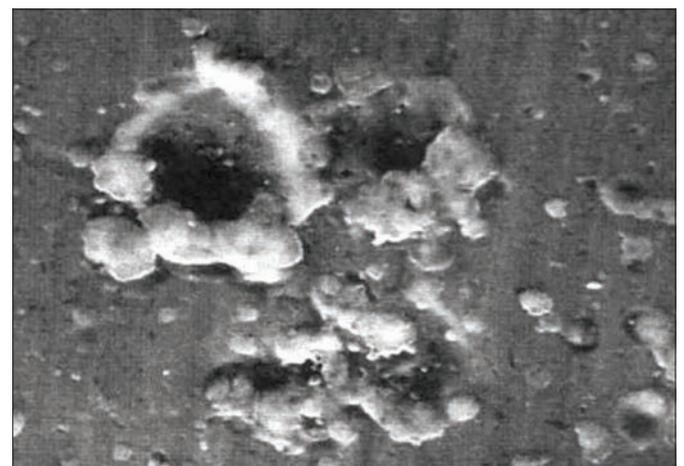
Figure 3: Localised corrosion occurs in a bearing race (magnified) as a result of spark erosion when shaft voltages are discharged through the bearings, leaving behind small melt craters.

premature failure of the bearing or motor. Within a short time, the bearing surface is strewn with microscopic scale melt craters [Figure 3], giving it a frosted appearance [Figure 4]. Over time, a corrugation (washboard-like surface) forms, resulting in increased bearing noise and vibrations [Figure. 5].

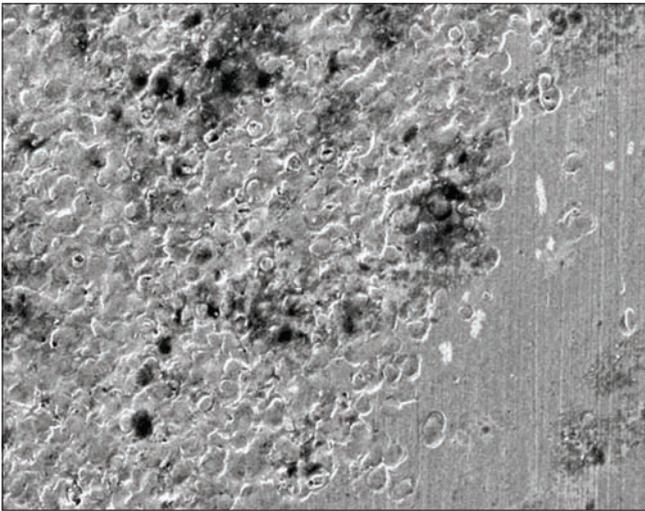
Figure 4: Small melt craters created by localised corrosion have a frosted appearance to the naked eye.

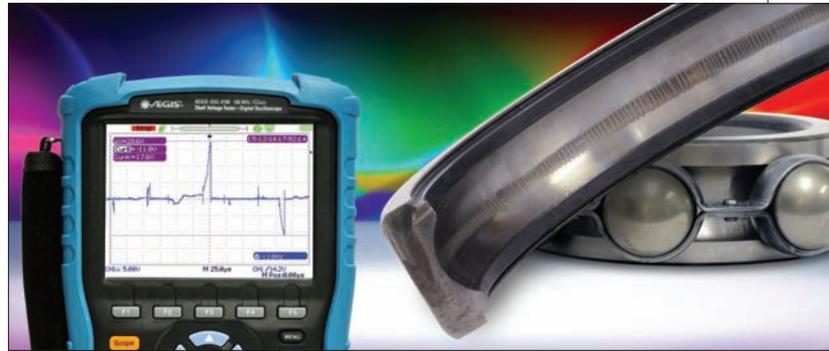
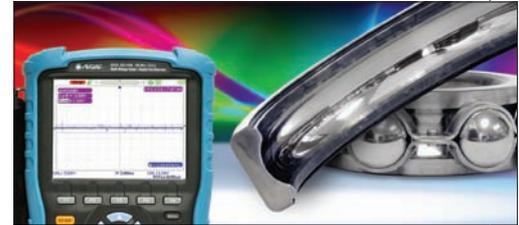
Figure 6: Oscilloscope voltage profile of bearing without shaft grounding (above) compared to bearing with Aegis bearing protection ring (right).

The effectiveness of Aegis shaft grounding rings can be quantified by simply measuring the shaft voltage by means of an oscilloscope. Without shaft grounding, the voltage profile exhibits high voltage peaks and steep discharge edges. After applying the bearing protection ring, a virtually flat line appears [Figure 6].

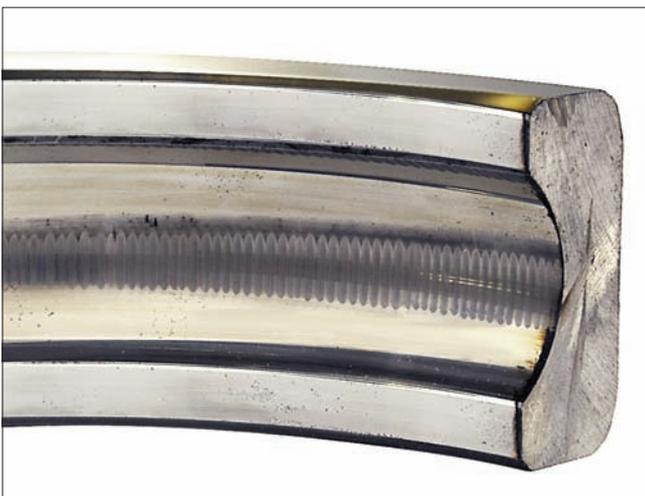
Figure 5: Corrugation of the bearing surface caused by localised corrosion results in increased bearing noise and vibrations.

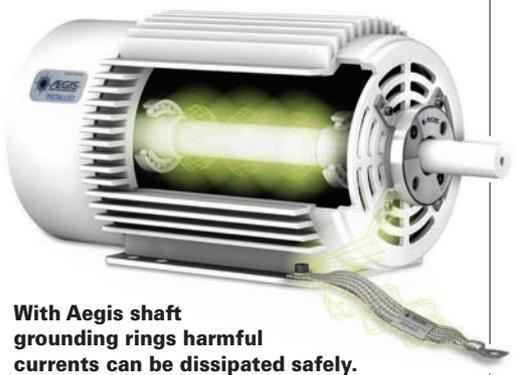
With Aegis shaft grounding rings harmful currents can be dissipated safely.
