## Protecting VFD-Driven Motors In: Commercial Ships

### Without Bearing Protection for Critical Systems, Commercial Ships Can End Up Dead in the Water

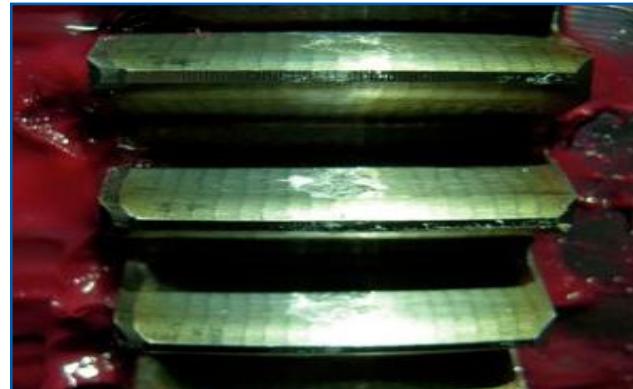
The problem was discovered when, after an overhaul, the auxiliary reduction gears failed only 120 days out of port. The ship was forced to return to the Shanghai shipyard for repairs to the reduction gears. But, the shipping line soon realized that the damage to the gears was merely a symptom of larger problem — electrical arcing in the gearbox. The shipping line needed to find a permanent solution to this problem before the ship could leave port. And a cost of \$10,000 per day for every day the ship remained in port, the shipping line needed to find a solution fast.

To assess the situation and recommend a fix, the shipping line called in Xview, the master distributor for AEGIS® Shaft Grounding Rings in China. After taking readings from the shaft of the generator, Xview technicians determined that high-frequency voltage spikes (4-6 volts) were being passed from the generator to the gearbox and were causing arcing in the gearbox and bearings.

Above: Pitting of auxiliary reduction gears due to electrical arcing  
Below: Pitting of bearing sleeve on high-speed side of gearbox

Xview recommended an AEGIS® PRO Ring, a bearing protection ring with multiple rows of conductive microfibers to bleed these voltages from the shaft safely to ground. The PRO ring was installed on the generator shaft with colloidal

silver coating. New measurements taken after the ring's installation showed readings of less than 2 volts. Based on these successful results, the shipping company installed AEGIS® PRO Rings on four other ships in its fleet.

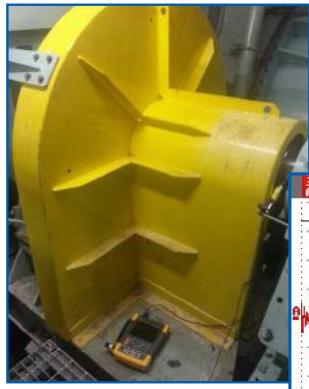
Voltages on generator shaft were causing arcing in and damage to the ship's auxiliary gearbox

Without AEGIS® PROSL: ▶  
6.04 V peak-to-peak

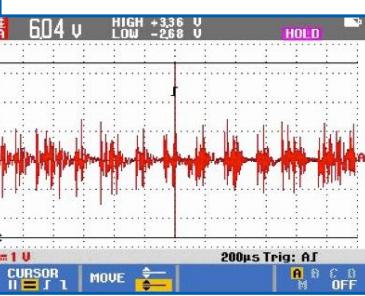
◀ Measuring damaging voltages on generator shaft to auxiliary gearbox

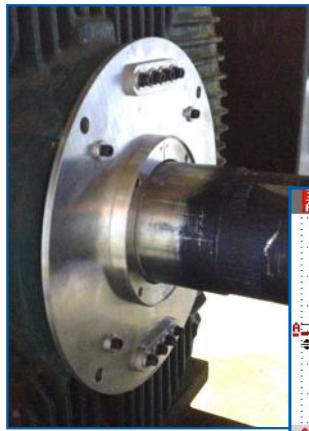
With AEGIS® PROSL: ▶  
1.36 V peak-to-peak

Installing an AEGIS® PROSL on the generator shaft channeled voltages safely to ground, preventing arcing and damage to gearbox

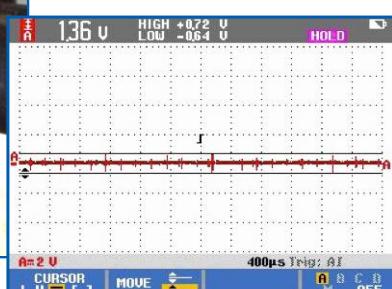
◀ AEGIS® PROSL installed on generator
