Local Motor Shop Helps Kansas Water Authority Solve Bearing-Damage Problem

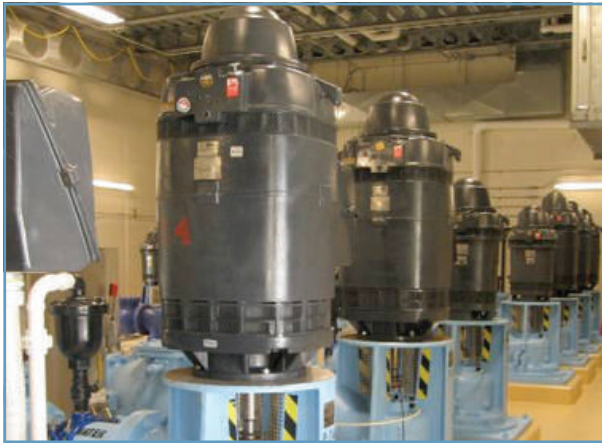
The motors atop these vertical hollow-shaft pumps (at the Reverse Osmosis Water Treatment Center in Hutchinson, Kansas) provide thrust to the pumps' drive ends.

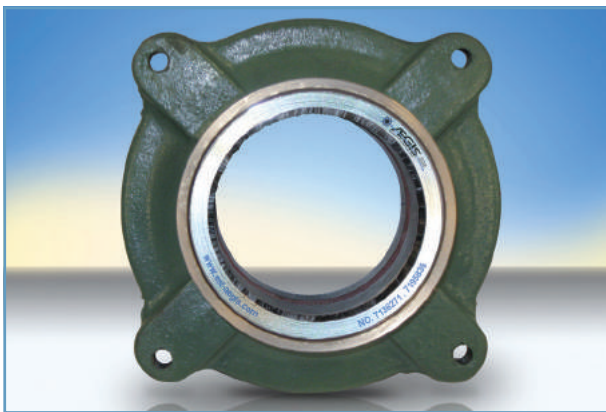
An AEGIS® Bearing Protection Ring mounted in the lower bearing retainer of a vertical pump motor.

IEMCO usually works on motors with failed bearings. After replacing the pitted bearings, his team installs a shaft grounding ring next to the motor's guide (lower) bearing and, using proprietary techniques, applies ceramic insulation to the carrier that holds the thrust (upper) bearing in place at the motor's drive end. For medium-voltage motors, Wilkins uses the larger AEGIS® PRO grounding ring, designed for motor shafts to 30" in diameter.

Key to the AEGIS® Bearing Protection Ring's effectiveness is its patented Nanogap Technology, which ensures superior contact/noncontact grounding protection for the normal service life of the motor's bearings.

The AEGIS® ring's unique design includes proprietary conductive microfibers arranged in a continuous circle

around the motor shaft, providing hundreds of thousands of voltage discharge contact points. These microfibers maintain electrical contact for the life of the bearing — even if physical contact is lost — through 3 distinct noncontact electron transfer processes that work simultaneously. These noncontact nanogap processes provide highly effective electron transfer — even in the presence of grease, oil, dust, and other contaminants — and are unaffected by motor speed. No other grounding product works with both contact and noncontact electron transfer, and no other product offers the long-term, maintenance-free performance of the AEGIS® ring.

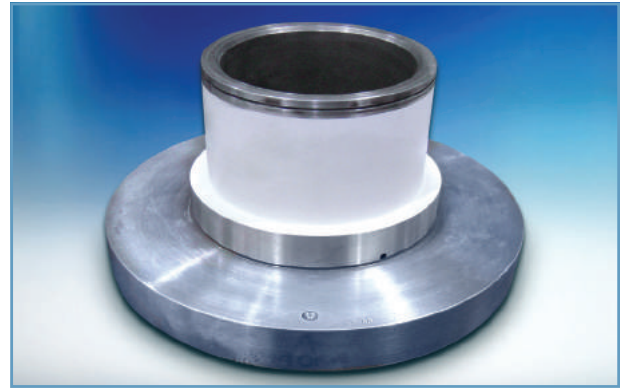
IEMCO coats all vertical pump motor carriers with ceramic insulation, using proprietary techniques.

Some carriers conduct electricity, but Wilkins is convinced that a carrier should be electrically isolated, disconnecting the motor from the pump shaft electrically though not mechanically. In addition to protecting the motor's thrust bearing from electrical damage, this keeps shaft currents from jumping to the bearings of the pump itself, or to the bearings of a gearbox, tachometer, encoder, etc.

To apply the coating of ceramic, IEMCO uses a tightly controlled flame-spray welding procedure. Wilkins' team also grinds each newly coated carrier to very tight tolerances. The finished carrier has a hardness of Rockwell 50C and provides a resistance of more than 1 gigaohm at 1000 volts — far better than the National Electrical Manufacturers Association (NEMA) standard of 1 megaohm at 500 volts.
