SL-08-025

# Shaft Grounding— A Solution to Motor Bearing Currents

## ABSTRACT

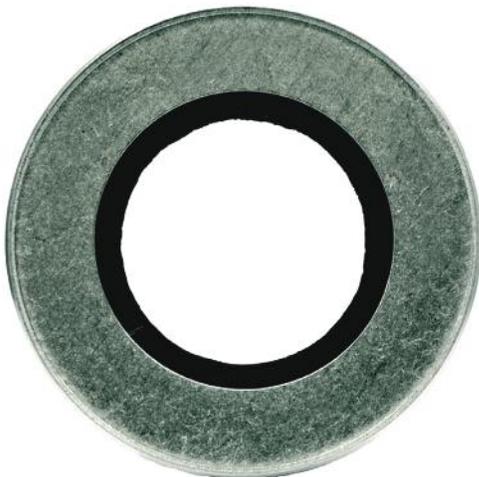
*Figure 3* Shaft grounding ring.

To improve the contact grounding brush performance in the shaft grounding ring, the brush wire material has been replaced with micro-diameter conductive fibers [22]. Figure 3 and Figure 4 show a conductive micro-fiber shaft grounding ring brush and a motor with the micro-fiber shaft grounding ring installed on the drive-end of the motor shaft, respectively. The micro-fibers surround the motor shaft completely to provide full contact with the shaft thereby minimizing the effect of the motor shaft eccentricity or vibration. Micro-fibers in the shaft grounding ring are not spring-loaded on the motor shaft while most contact grounding brushes are spring-loaded. The micro-fiber brushes are either press-fitted into the housing or mounted on the motor faceplate with two small screws.

This micro-fiber brush construction provides several advantages over the spring-loaded contact brushes. First, the wear rate of micro-fibers is very low, due to an insignificant force between the light weight micro-fibers and the shaft. As a result the heat generation of the fibers during operation is negligible, at even high rotating speeds. Tests at up to 14,000 rpm for 3000 hours have shown negligible wear indicating much longer life at the lower rotating speeds found in HVAC applications. Micro-fiber brushes are said to have no speed limitation [29]. Second, the current limits of micro-fibers are in general much higher than that of a conventional brushes or a solid carbon brush since micro-fibers can provide a large real contact area on a sliding surface, thereby greatly improving the efficiency of shaft voltage discharges. Third, the micro-fibers create a corona discharge at the tip of the fibers when the fibers are over a charged surface. Recent hard-disc manufacturer reports that currents can flow to a small diameter point without an intimate contact even though the surface voltage is

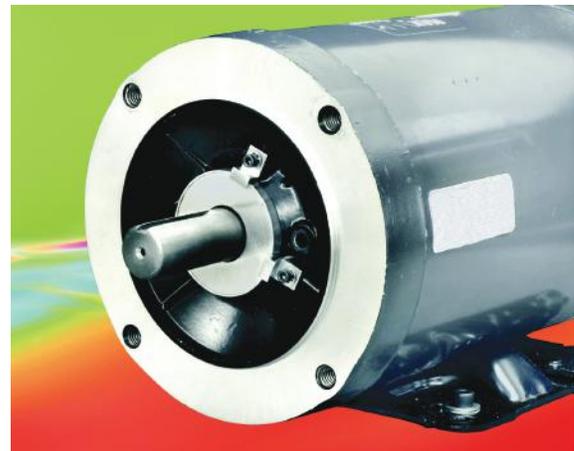
*Figure 4* Shaft grounding ring installed on motor.
