Shaft Grounding Ring Case Study

250 HP VFD Driven Motor

Case Study: 250 HP Chilled Water Pump

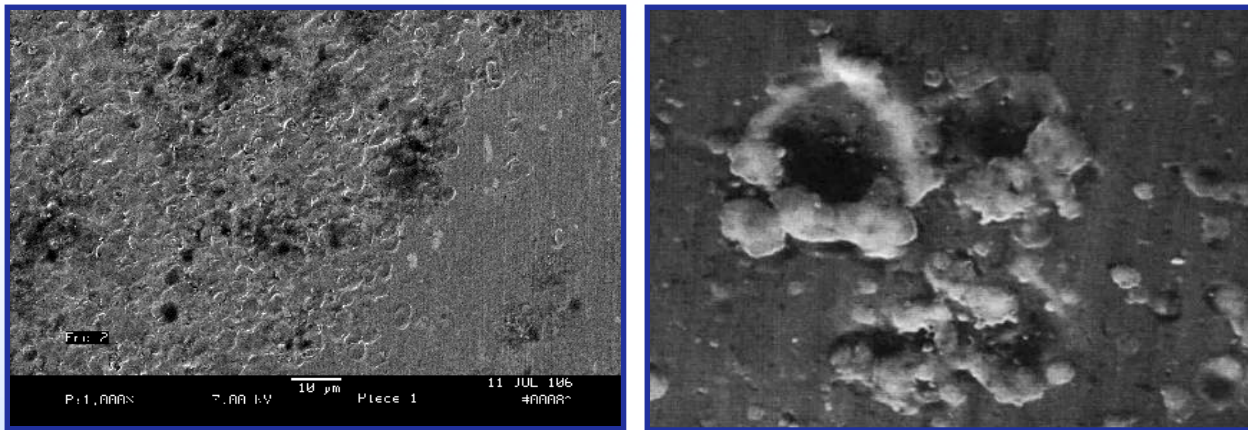
Pitting due to Electrical Discharge Machining as seen under an electron microscope

Voltage arcs through the bearing

- Voltage arcs through bearing, and electrical discharge machining (EDM) produces thousands of pits
- Eventually, the rolling ball bearing causes fluting damage to race
- Bearings degrade, resulting in bearing and motor failure

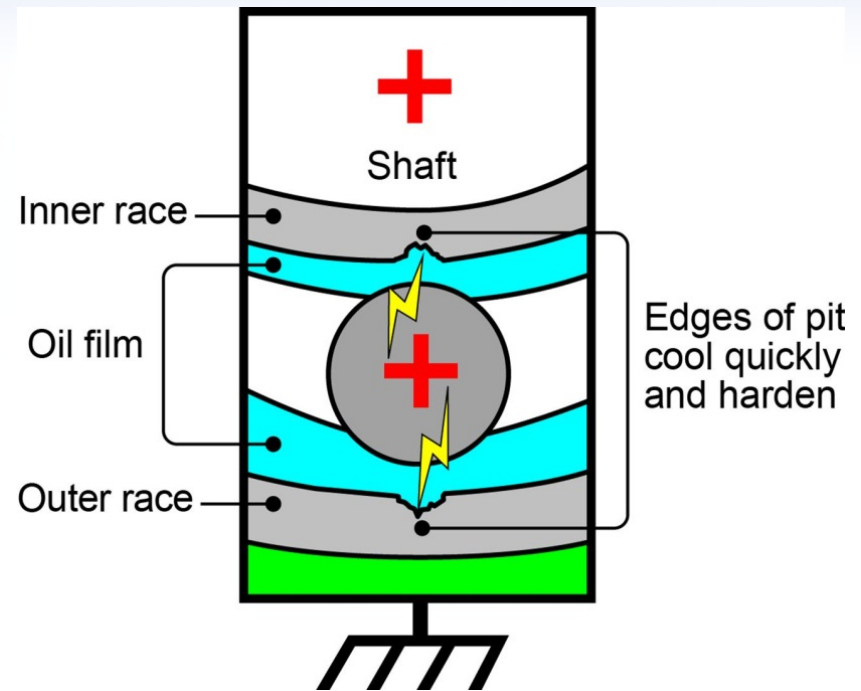
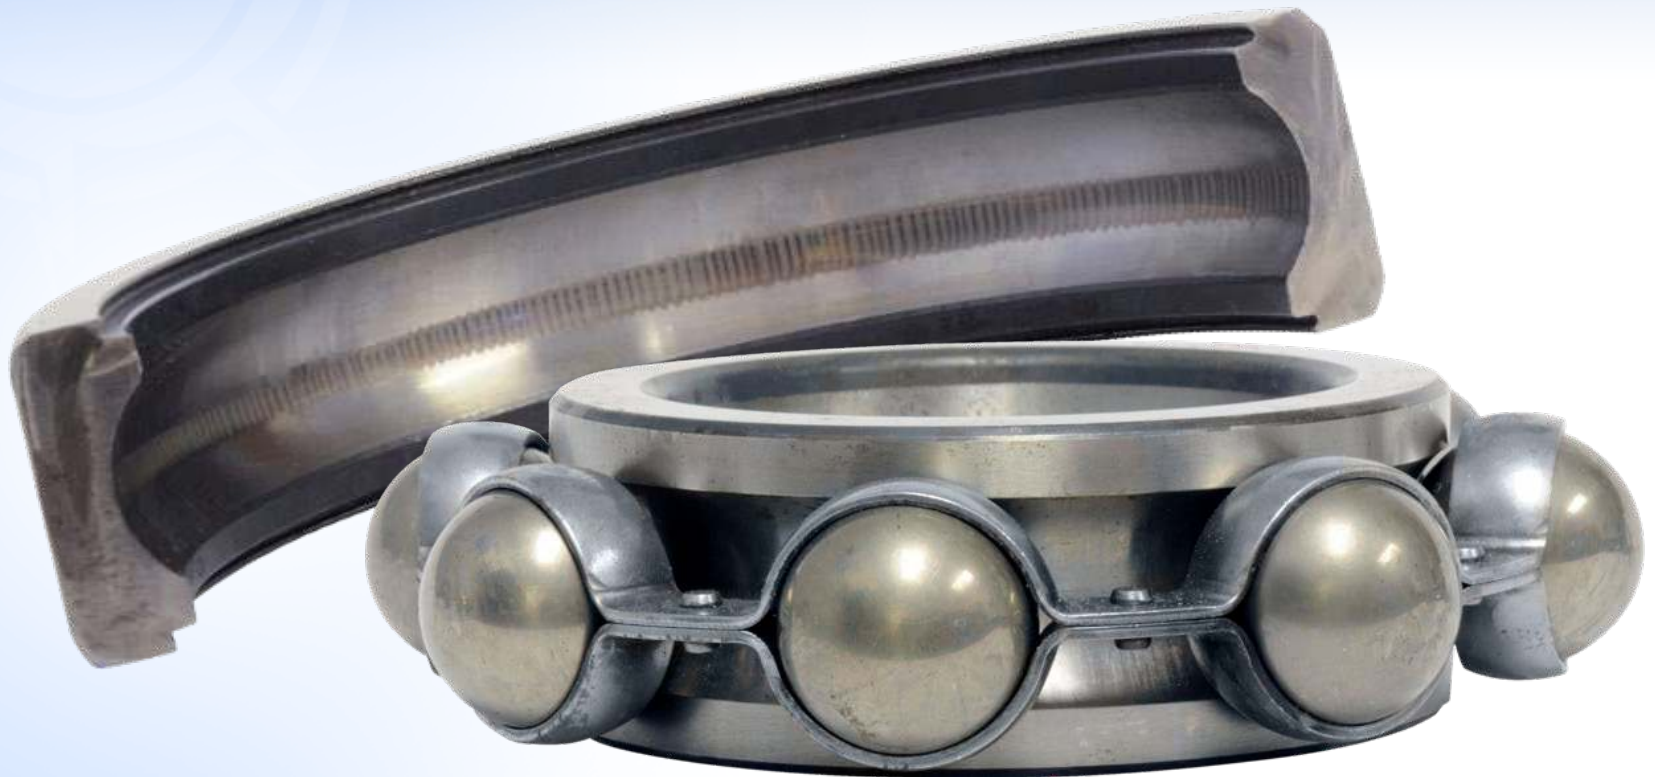
Result in Fluted Bearings

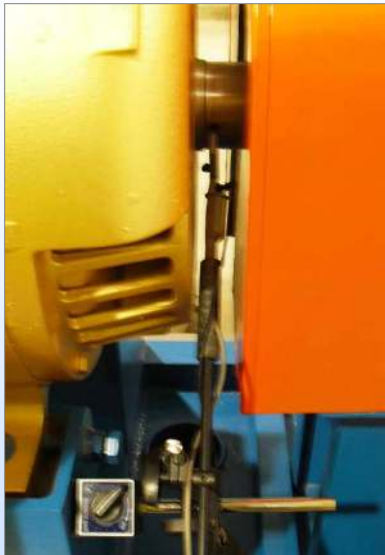
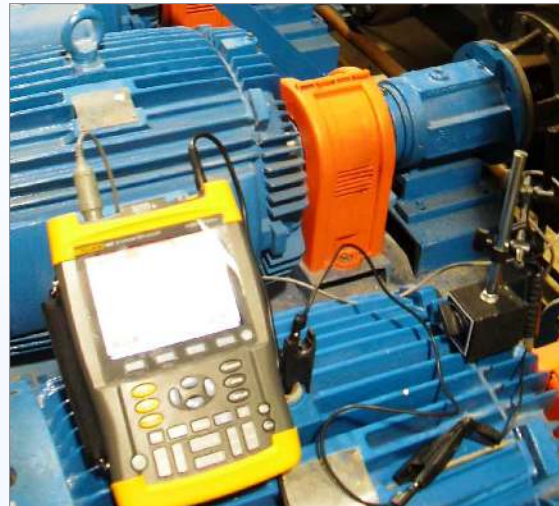
- These chilled water pump systems have been operating for 12-18 months. Audible bearing noise already present 4 out of 12 pump motors.
- Audible noise is typical of the washboard pattern known as “fluting” that is the result of shaft voltages discharging through the motor’s bearings.

Pump systems tested in case study.

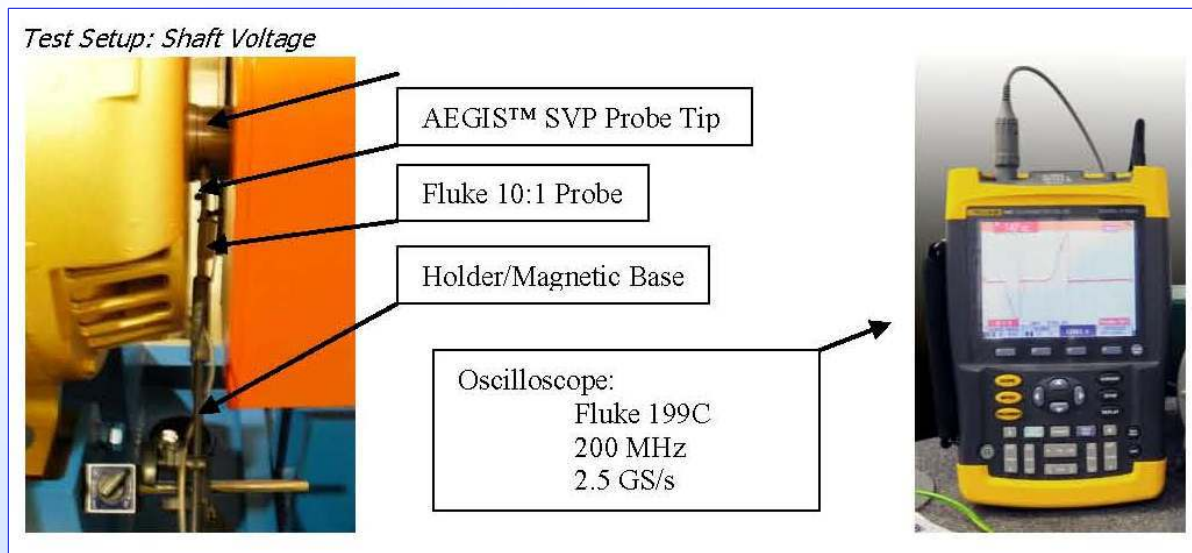
Test Measurement Objective: Measure Shaft Voltage

- **Test setup**: Fluke 199C 200MHz Scopemeter with AEGIS® SVP tip on Fluke 10:1 probe applied to the motor shaft while operating.
- **Objective**: Determine if there is an induced voltage on the motor shaft and check for bearing discharge wave form.

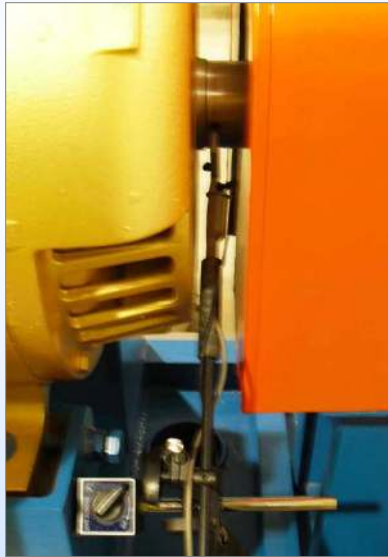
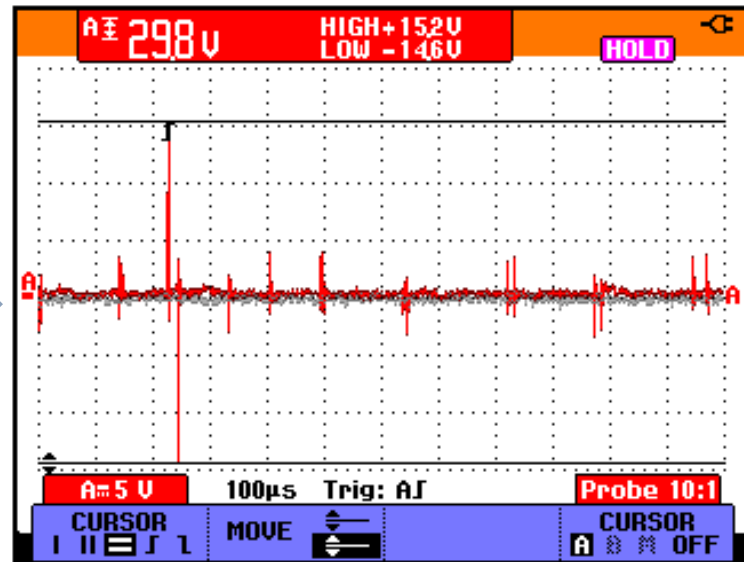
250 HP Motor on VFD

VFD Induced Shaft Voltage

Reading 1: 29.8 v pk – pk with positive and negative voltage spikes present of ~14-15v pk indicates bearing current discharges. Audible bearing noise present indicates “fluting” damage to bearing race.

Fluke 199C Setting: 5 v/div; 100usec/div

- **Reading 1:** 29.8 volts peak to peak
- **Reading 2:** 18.4 volts peak; 16.66 MHz dv/dt

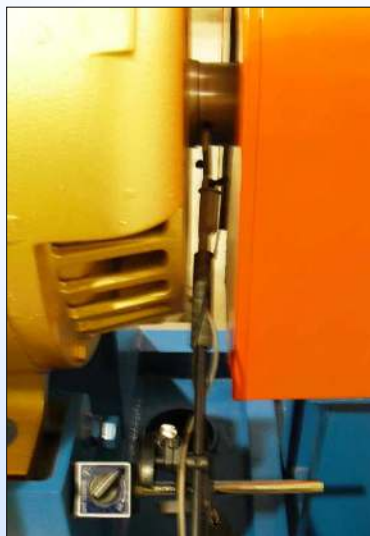
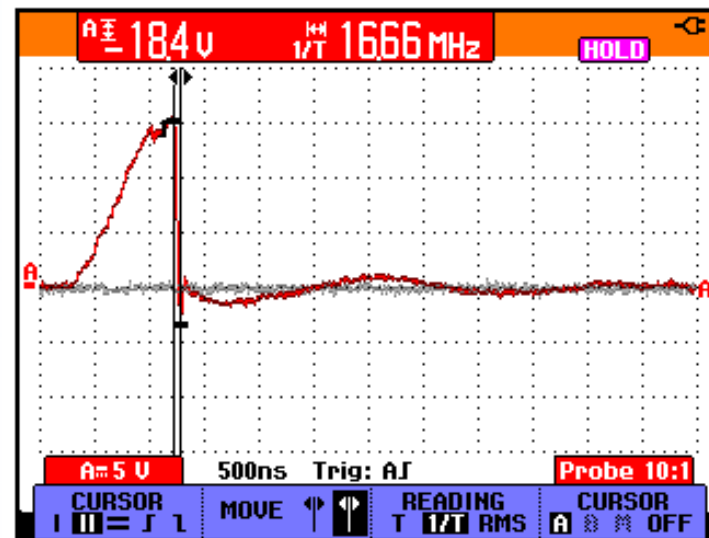
250 HP Motor on VFD

VFD Induced Shaft Voltage

Reading 2: Bearing discharge waveform - 18.4 volt peak - slower voltage rise and sharp discharge trailing edge. The trailing edge voltage drop occurs when oil film breaks down. The 16.6 MHz ultra high frequency dv/dt event causes the EDM pit in the bearing race.

Reading: Shaft Voltage Reading DE Fluke 199C Setting: 5 v/div; 500 nsec/div

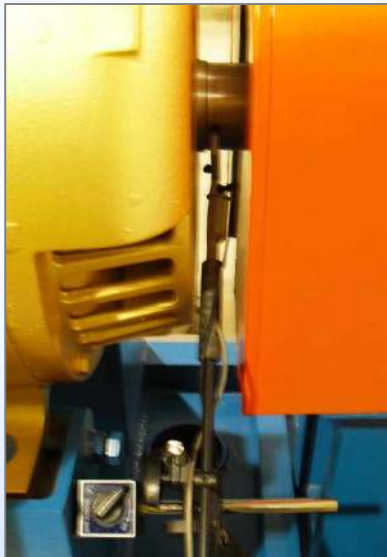
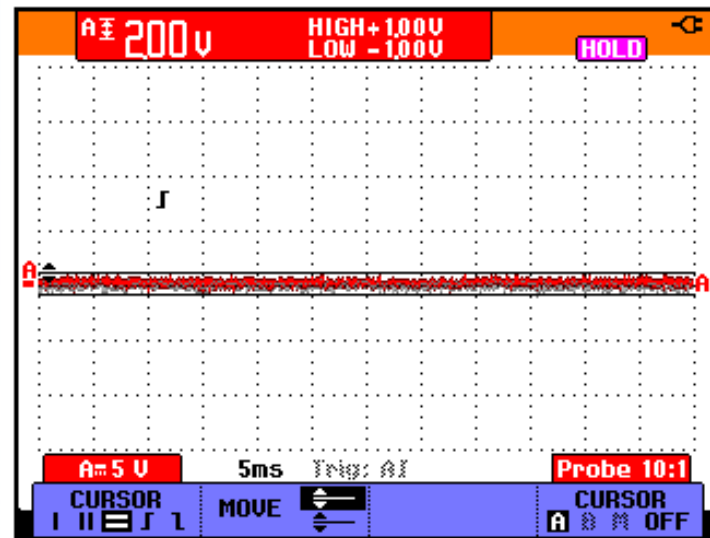
250 HP Motor on VFD

Shaft Grounded with AEGIS® Ring

Reading 3: 2.0 v pk-pk ground noise present on the motor shaft. AEGIS® shaft grounding provides “path of least resistance.” **No bearing discharges.**

Reading: Shaft Voltage Reading DE Fluke 199C Setting: 5 v/div; 5 msec/div

- **Reading 3:** 2.0 volts peak to peak
- Motor bearings protected with AEGIS® Shaft Grounding

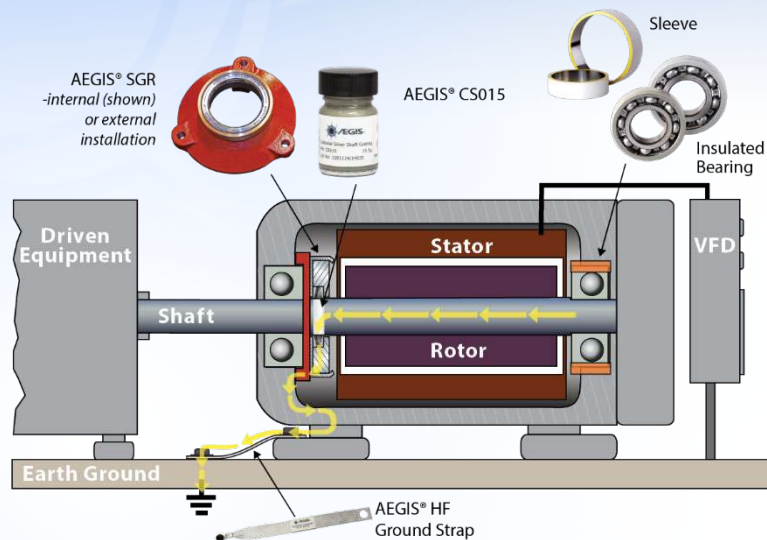
Motors Greater than 100 HP (75 kW) - *Low Voltage*

Install AEGIS® Ring on opposite end from insulation

Product recommendation:

Motors up to 500HP: AEGIS® SGR

Motors over 500HP: AEGIS® PRO Series

For horizontally mounted motors with single row radial ball bearings on both ends of the motor:

- Non-Drive end: Bearing housing must be isolated with insulated sleeve or coating or use insulated ceramic or hybrid bearing to disrupt circulating currents.
- Drive end: Install one AEGIS® Shaft Grounding Ring .
- AEGIS® Ring can be installed internally on the back of the bearing cap or externally on the motor end bracket.
- Use AEGIS® Colloidal Silver Shaft Coating (PN# CS015) on motor shaft where fibers touch.

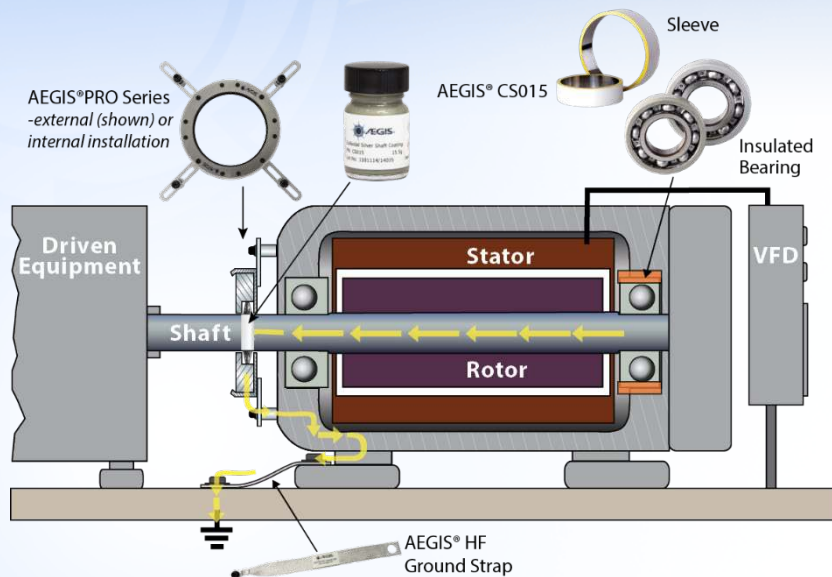
Motors Greater than 100 HP (75 kW) - *Medium Voltage*

Install AEGIS® Ring on opposite end from insulation

! Product recommendation: AEGIS® PRO Series

For horizontally mounted motors with single row radial ball bearings on both ends of the motor:

- Non-Drive end: Bearing housing must be isolated with insulated sleeve or coating or use insulated ceramic or hybrid bearing to disrupt circulating currents.
- Drive end: Install one AEGIS® Shaft Grounding Ring .
- AEGIS® Ring can be installed internally on the back of the bearing cap or externally on the motor end bracket.
- Use AEGIS® Colloidal Silver Shaft Coating (PN# CS015) on motor shaft where fibers touch.
