## Case Study

### Installation of AEGIS SGR™ Bearing Protection Ring at Time Life Building

**Date:** March 9, 2009

**Location:** Time Life Building  
1271 6<sup>th</sup> Avenue  
Rockefeller Center  
New York City, NY

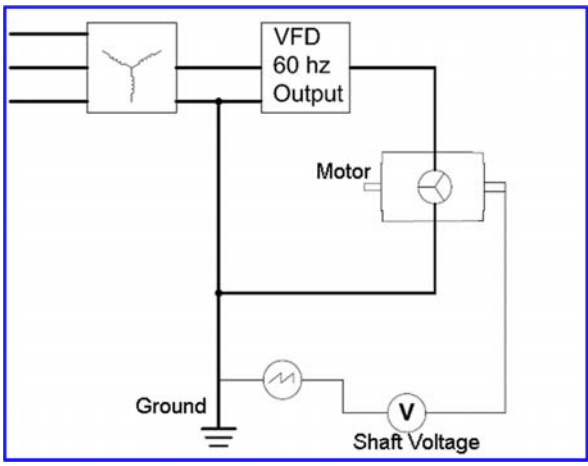
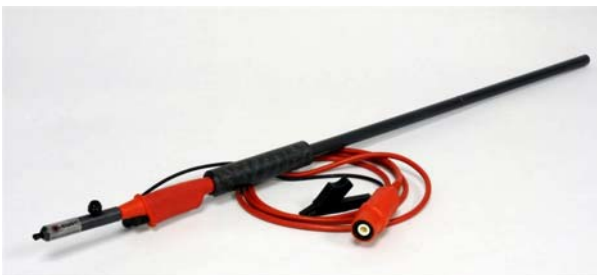
<p><b>Reading #1</b></p> <div style="background-color: blue; color: white; padding: 5px; text-align: center; width: fit-content; margin: 0 auto;">Voltage 4.80</div> <p><b>AEGIS SGR Bearing Protection</b></p>

- (7) The reading observed after 12 months was also a greatly reduced peak-peak reading of 4.8 volts indicating continued effective operation of the AEGIS SGR.
