Remember to follow the ABCs of bearing inspection

By Chuck Yung
EASA Senior Technical Support Specialist

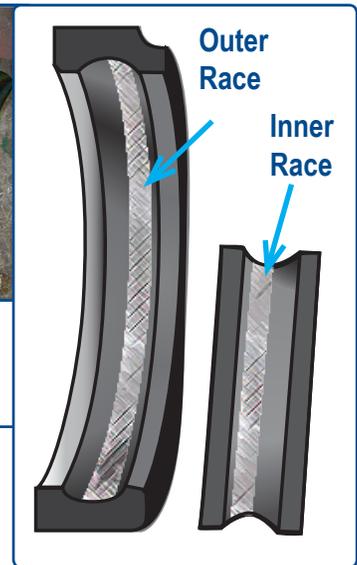
- **Shaft currents and contamination.** A washboard appearance called fluting (**Figure 3**) is indicative of shaft currents (also known as bearing currents), which are increasingly common when motors are powered by variable-frequency drives (VFDs). A highly frosted wear path is either caused by VFD-related shaft currents or dirt embedded in the grease. Use a 20x magnifier to look more closely. Electrical pitting on the race or rolling element will have a melted appearance along the edges, whereas contamination causes a rougher cratering.

Whatever you find and however you solve the problem—don't just change the bearings. An internal preload condition requires the non-locating bearing housing to be machined deeper to gain sufficient room for thermal expansion of the shaft. A good rule of thumb is to provide 0.010" per foot (0.75 mm per meter) of shaft length between bearings.
