## Local Motor Shop Helps Kansas Water Authority Solve Bearing-Damage Problem

# CORRO-DUTY® Vertical HOLLOSHAFT® Inverter Duty Motors

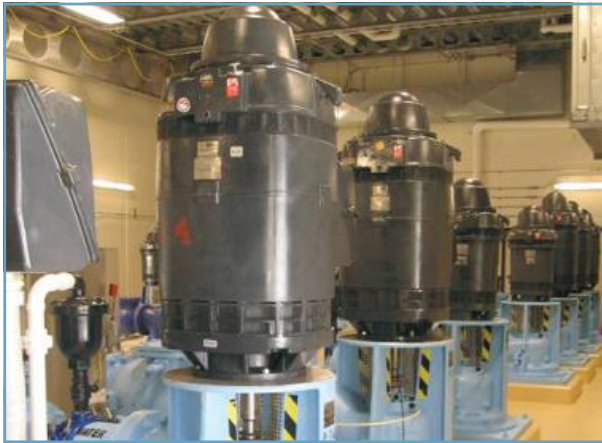
The motors atop these vertical hollow-shaft pumps (at the Reverse Osmosis Water Treatment Center in Hutchinson, Kansas) provide thrust to the pumps' drive ends.

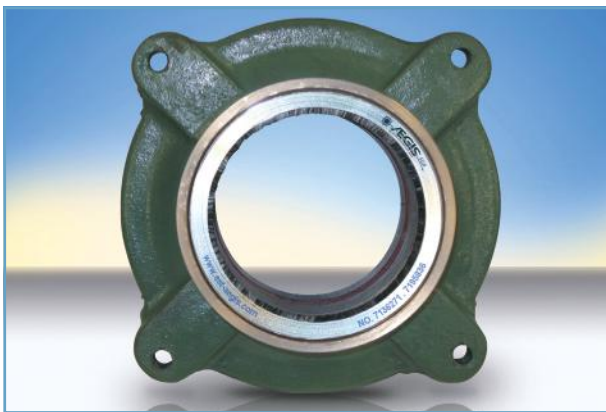
An AEGIS® Shaft Grounding Ring mounted in the lower bearing retainer of a vertical pump motor.

IEMCO usually works on motors with failed bearings. After replacing the pitted bearings, his team installs a shaft grounding ring next to the motor's guide (lower) bearing and, using proprietary techniques, applies ceramic insulation to the carrier that holds the thrust (upper) bearing in place at the motor's drive end. For medium-voltage motors, Wilkins uses the larger AEGIS® PRO grounding ring, designed for motor shafts to 30" in diameter.

Key to the AEGIS® Shaft Grounding Ring's effectiveness is its patented Nanogap Technology, which ensures superior contact/noncontact grounding protection for the normal service life of the motor's bearings.

The AEGIS® ring's unique design includes proprietary conductive microfibers arranged in a continuous circle

around the motor shaft, providing hundreds of thousands of voltage discharge contact points. These microfibers maintain electrical contact for the life of the bearing — even if physical contact is lost — through 3 distinct noncontact electron transfer processes that work simultaneously. These noncontact nanogap processes provide highly effective electron transfer — even in the presence of grease, oil, dust, and other contaminants — and are unaffected by motor speed. No other grounding product works with both contact and noncontact electron transfer, and no other product offers the long-term, maintenance-free performance of the AEGIS® ring.

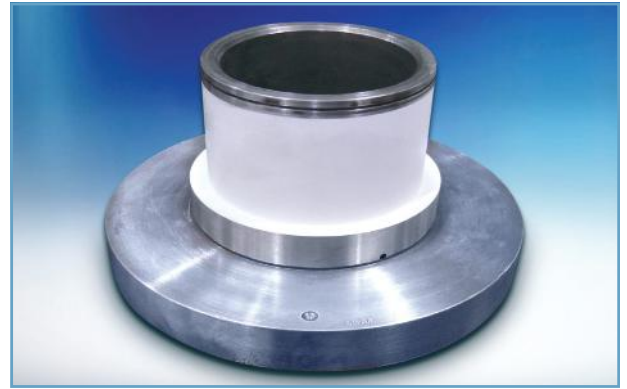
IEMCO coats all vertical pump motor carriers with ceramic insulation, using proprietary techniques.

For vertical hollow-shaft motors, IEMCO's systematic approach requires the AEGIS® ring to remove the voltage and a well-tooled carrier to control the voltage until it is removed, so it doesn't transfer to attached equipment.

Some carriers conduct electricity, but Wilkins is convinced that a carrier should be electrically isolated, disconnecting the motor from the pump shaft electrically though not mechanically. In addition to protecting the motor's thrust bearing from electrical damage, this keeps shaft currents from jumping to the bearings of the pump itself, or to the bearings of a gearbox, tachometer, encoder, etc.

To apply the coating of ceramic, IEMCO uses a tightly controlled flame-spray welding procedure. Wilkins' team also grinds each newly coated carrier to very tight tolerances. The finished carrier has a hardness of Rockwell 50C and provides a resistance of more than 1 gigaohm at 1000 volts — far better than the National Electrical Manufacturers Association (NEMA) standard of 1 megaohm at 500 volts.
