Local Motor Shop Helps Kansas Water Authority Solve Bearing-Damage Problem

Case Study - Kansas Water Authority

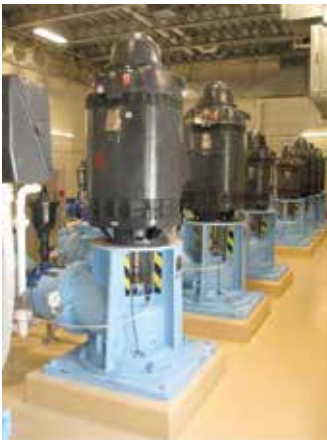
After the first 10 damaged motors had been successfully reconditioned, Koci sent the plant's remaining 7 pump motors to IEMCO for preventive maintenance, at the city's expense. Four were horizontal pump motors, in which IEMCO installed an AEGIS® ring at the non-drive end and ceramic-coated bearings at the drive end. By the end of 2011, all 17 of the plant's pump motors were protected from electrical bearing damage. Today, they are all still running without any problems.

IEMCO usually works on motors with failed bearings. After replacing the pitted bearings, his team installs a shaft grounding ring next to the motor's guide (lower) bearing and, using proprietary techniques, applies ceramic insulation to the carrier that holds the thrust (upper) bearing in place at the motor's drive end. For medium-voltage motors, Wilkins uses the larger AEGIS® PRO grounding ring, designed for motor shafts to 30" in diameter.
